NASA Contractor Report 3715

**DC-10 Composite Vertical Stabilizer
Ground Test Program**

**J. M. Palmer, Jr., C. O. Stephens,
and J. O. Sutton**

**CONTRACT NAS1-14869
AUGUST 1983**

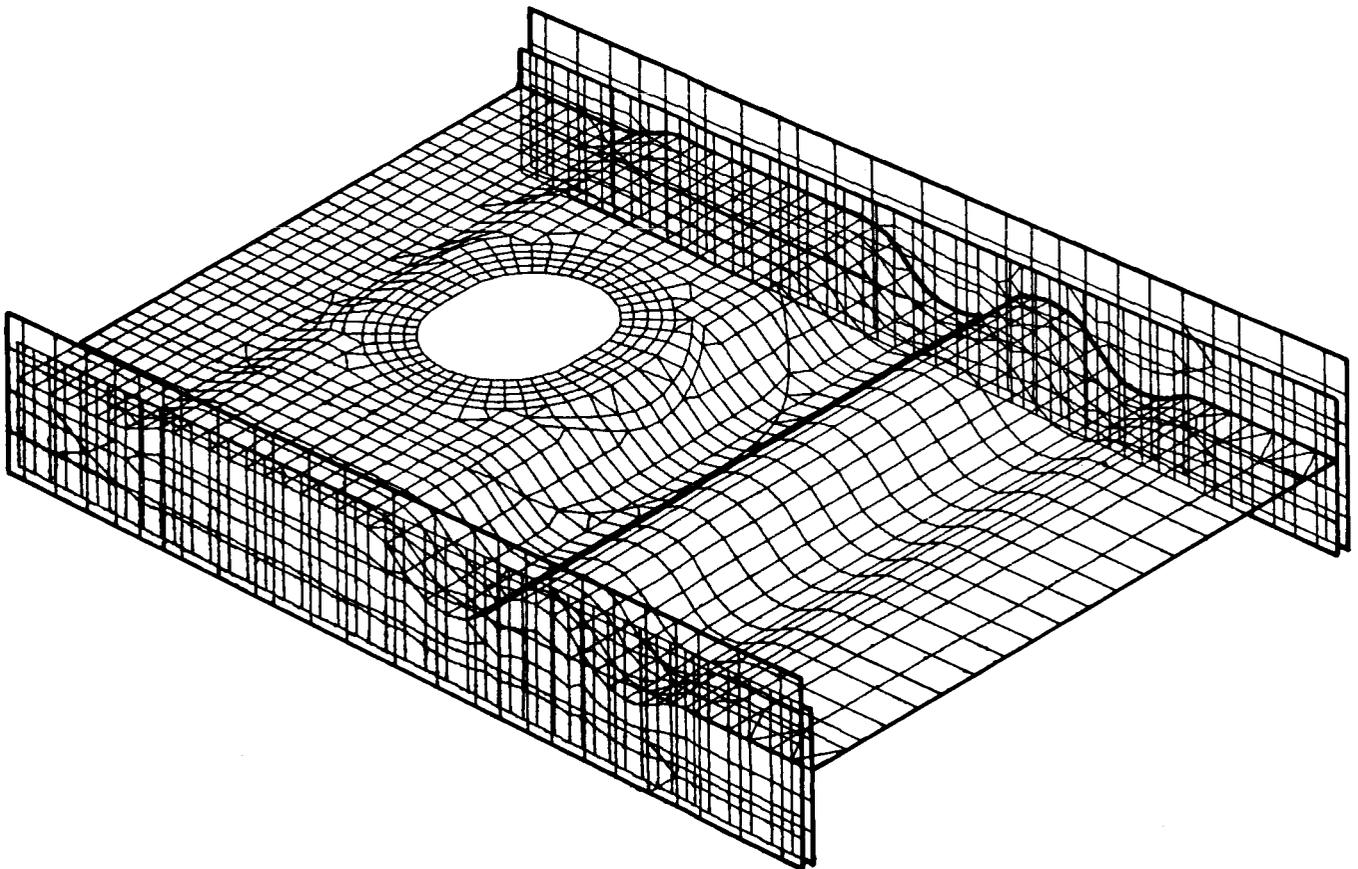
FIGURE 24. NASTRAN MODEL OF REAR SPAR WEB

The second area of investigation was the covered cutouts in the rear spar web and the center bay of the Z_{FR} Station 314 rib. A simple planar analysis indicated that the strains at the perimeter of the cutouts were not critical even with the door missing. However, it was recognized that the sine wave web produces significant out of plane forces at the hole which would modify those results. Accordingly, a detailed three dimensional NASTRAN model of the critical rear spar web was developed (Figure 24). Web shear, spar cap and bolted joint interface loads were applied to the model while the attachment of the door module to the web module was analytically varied from full shear effectivity to zero shear effectivity. A reference case with no door installed was also run. The results are shown in Figure 25, where the laminate mid-plane strains at the perimeter of the access opening are plotted for each quality of fastener fit. Clearly, if sufficient slippage between the door and web is available, the presence of the fasteners provides almost no relief from the maximum strains, while fully effective fasteners (i.e., a fully effective door) provides considerable support at the edge of the cutouts.

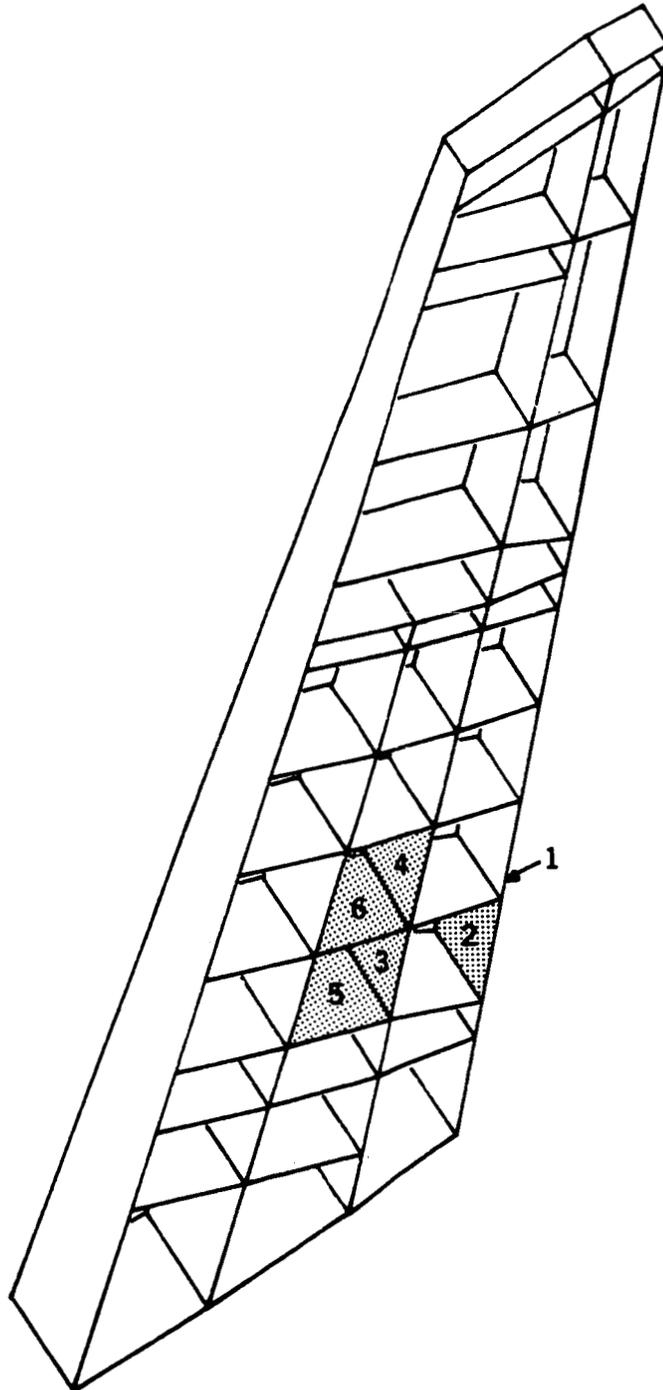
FIGURE 26. FAILURE INITIATION INVESTIGATION POINTS

The NASTRAN internal loads model for the complete stabilizer was next modified to reflect assumed failures in areas which were failed in both the stub box and GTU in order to establish the probable failure initiation point. The locations are shown in Figure 26. Loads equal to the test loads at failure were applied to the model. Only the assumed failure in the rear spar web between Z_{FR} Stations 326 and 350 resulted in negative margins of safety for the remaining structure.

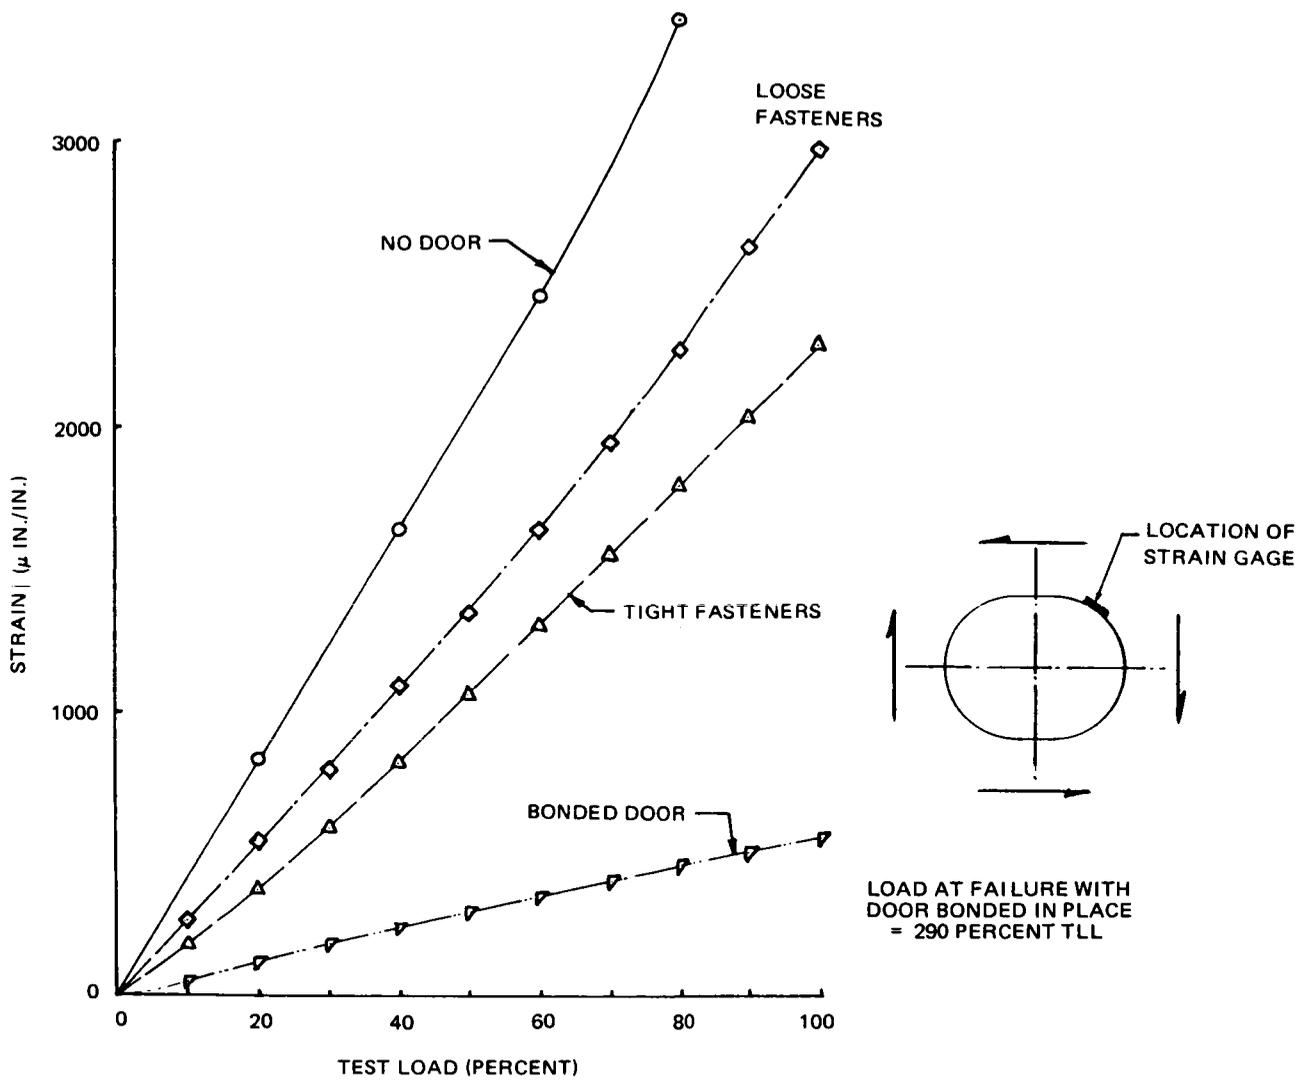
FIGURE 33. STRAIN AT PERIMETER OF CUTOUT IN AMC7855-5 RIB COMPONENT

To test the validity of the concept, a flanged plate was made and installed on the AMC7855-5 rib test specimen (Figure 31). The panel was tested to failure, with failure occurring in the basic sine-wave web, well away from the opening (Figure 32). The strains measured at the perimeter of the hole with the bonded cover in place are shown in Figure 33.
